## IN-LINE INSPECTION IN LIEU OF HYDROSTATIC TESTING FOR LOW FREQUENCY ELECTRIC RESISTANCE WELDED PIPE

**Matt Krieg**  
Marathon Pipe Line LLC  
Findlay, Ohio, USA

### ABSTRACT

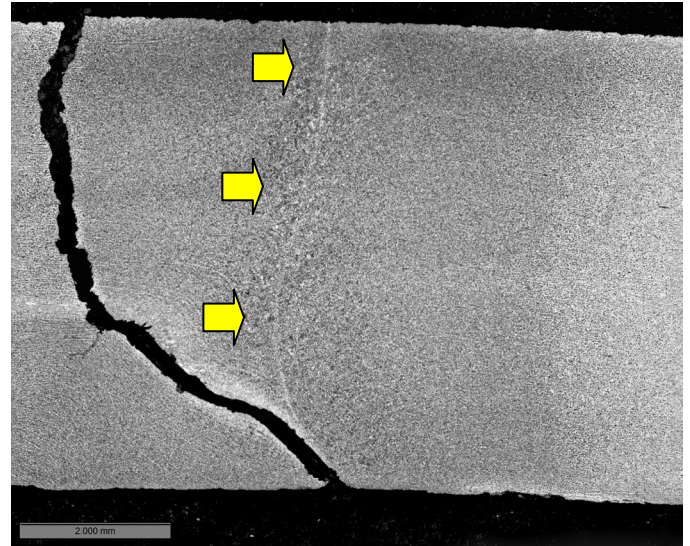
The subject pipeline was constructed with LF-ERW pipe made in 1956 by Republic Steel. A common assumption is that the weld bondline is straight and perpendicular to the inner and outer surfaces. This is a logical assumption, since it is likely that an equal amount of steel is displaced for each plate edge when the two square plate edges are forced together and the welding current is applied. This straight, perpendicular geometry is common for nearly all high frequency (HF) ERW welds and many low frequency welds. However, for this pipe, the bondline can be curved as illustrated in Figure 1. The figure also shows a crack that was broken open by impact after being cooled in a liquid nitrogen bath. This hook crack was connected to the inside diameter (ID) (bottom of the image) and followed the flow lines through a third of the wall thickness. The chilled forced fracture (CFF) portion of the break is nearly perpendicular to the OD surface.

**Figure 1. Curved ERW bondline in Republic ERW pipe.**

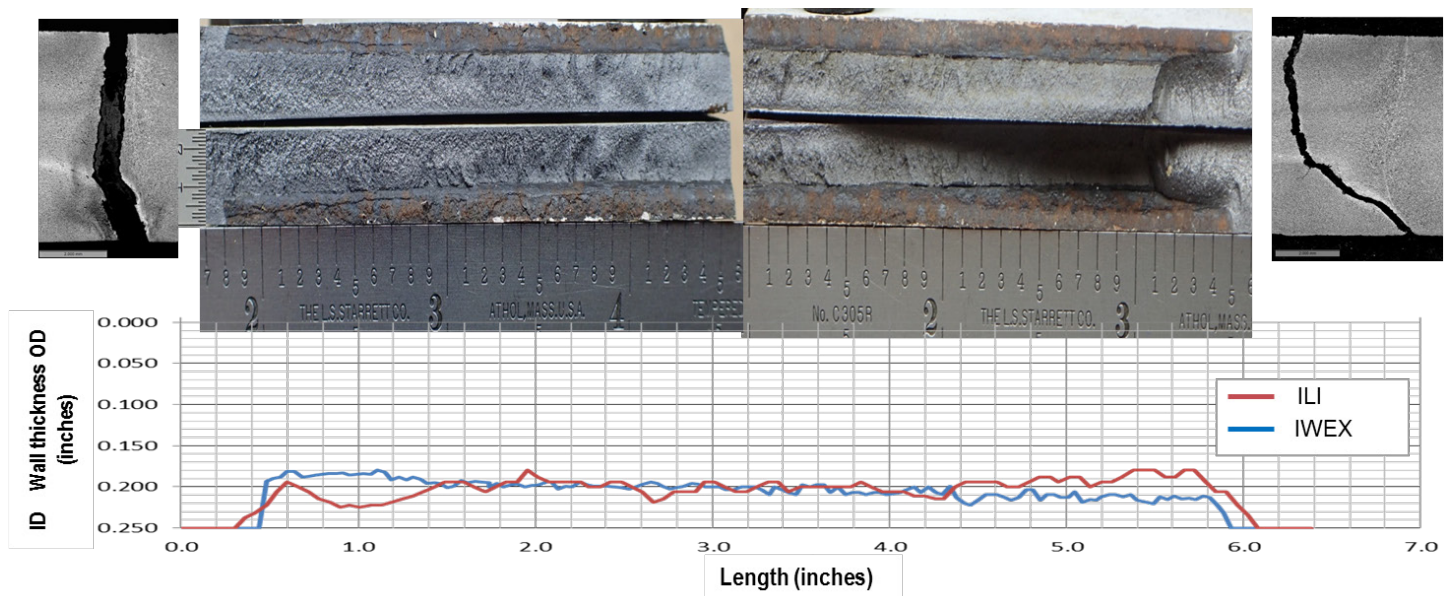
**Error! Reference source not found.**6 shows a hook crack that is nearly perpendicular to the surface on the left edge and at about a 45-degree angle on the right edge. This depth as determined by CFF was 0.04 inch (1mm) for the open hook crack and a 0.02 inch (0.5mm) segregation band for the left side expanding to 0.04 inch (1mm) for the open hook crack and 0.04 inch (1mm) segregation band for the right side. The profiles for the crack generated by the UT crack tool and IWEX inspection methods are in close agreement. This anomaly was particularly difficult to size because of the difference in the amplitude of the signals for transducers sending ultrasonic energy in the

clockwise or counterclockwise direction. It was not clear whether the segregation band was intact or cracked during the inspection making absolute determination of accuracy debatable.

**Figure 6. A hook crack that is nearly perpendicular to the surface on the left edge and at about a 45 degree angle on the right edge.**

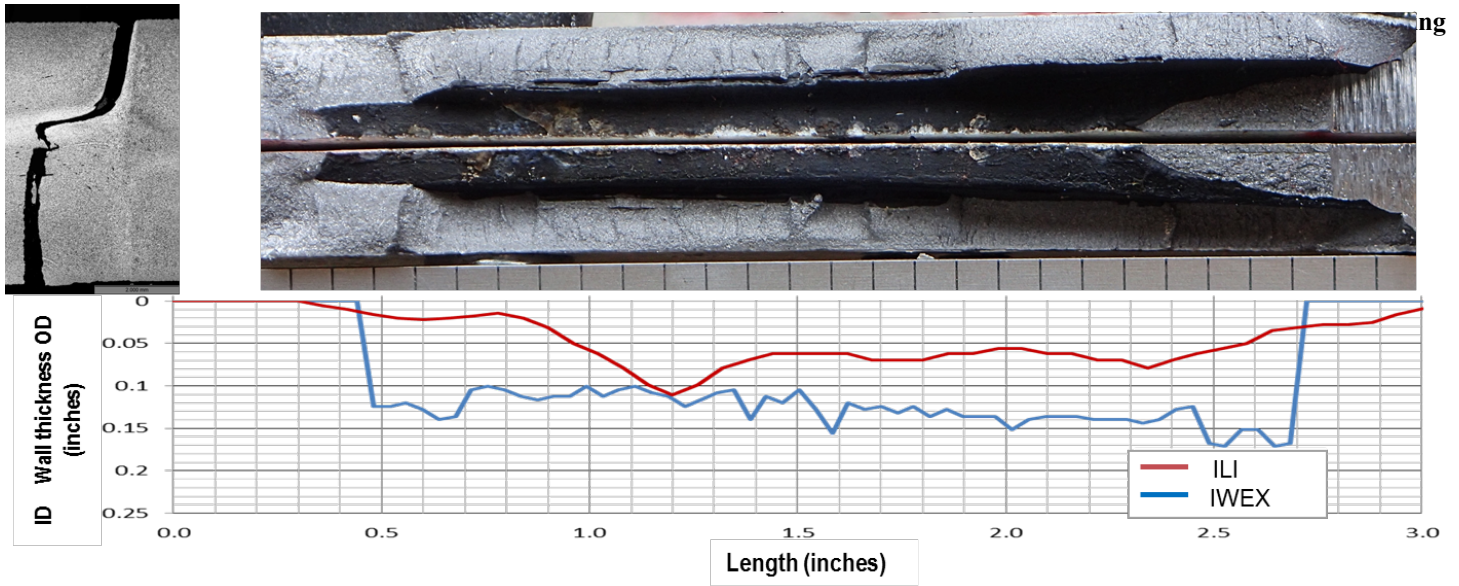
Figure 7 shows a hook crack which formed from a sloping lamination; this anomaly was 40 percent deep at the ID on the left edge and approximately mid-wall at the right edge. This hook crack was nearly perpendicular to the surface at the OD of the surface and quickly changed parallel to the surface near the mid-wall. The metallograph of the CFF is shown in Figure 8. This metallograph also shows the ERW electrode contact points with a benign planar anomaly on the left. The magnetic particle inspection detected both the hook crack and the contact mark. In the absence of a hook crack or well-defined trim, contact marks such as these can be reported by field NDE as cold welds unless properly characterized by the ultrasonic NDE method. The IWEX imaging of this anomaly showed a good correlation of length and depth and clearly identified the contact mark. The UT crack tool length correlated well but the depth was generally underestimated. For this anomaly, the ILI tool recorded signals from many sensors for both sides of the weld, but the geometry of this anomaly caused amplitudes to vary. While this anomaly visually appears to be significant, it passed 9 hydrostatic tests and did not show any signs of growth by fatigue.

**Figure 7. Hook crack that formed from a sloping lamination.**

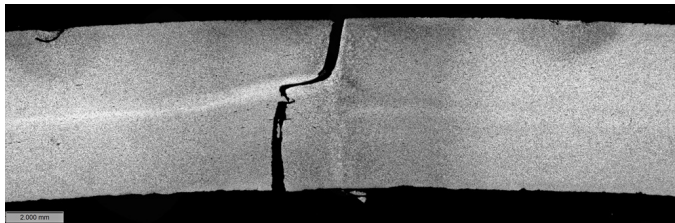
**Figure 8. The metallograph of the hook crack opened by CFF with fracture surfaced mated.**

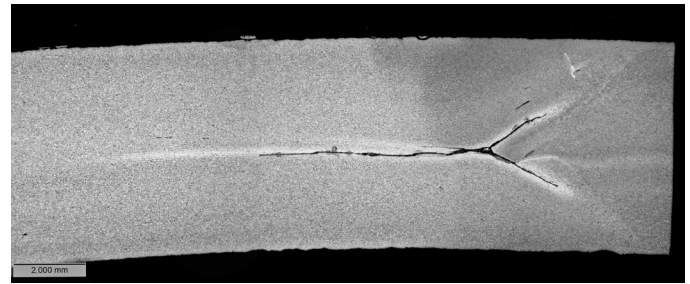
**Figure 9. Forked lamination with distorted seam.**

Some unusual anomalies in the seam were detected by ILI of NDE methods that typically do not impact integrity nor would they be detected by a hydrostatic test. One such feature is a forked lamination with a distorted seam shown in Figure 9. For this anomaly, the midwall lamination was exposed on one plate edge. When the two plates were forced together to form the ERW weld, the steel from the solid plate edge flowed into the lamination. This anomaly was over a foot (30cm) in length. At the upstream edge of this anomaly, a hook crack that broke to the ID formed. In 2013, UT crack tool inspections by two vendors identified the entire anomaly as a hook crack. The most recent inspection with the higher resolution UT crack tool correctly identified the midwall feature and the hook crack separately. The IWEX image of this anomaly, shown in Figure 10, shows the midwall lamination and the crack tip diffraction signals from the ends of the forked lamination. It also shows that the anomaly does not extend to the ID or OD of the pipe. Again, this anomaly passed 9 hydrostatic tests and did not show any signs of growth by fatigue.

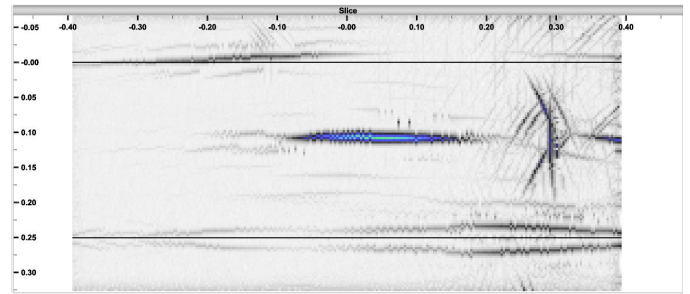
**Figure 10. IWEX image of forked lamination.**

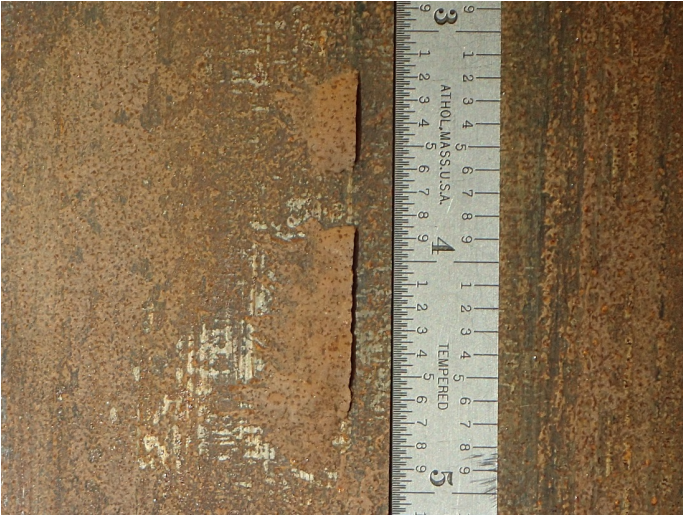
Another seam weld anomaly that typically does not impact integrity, nor would it be detected by a hydrotest is shown in Figure 11. This is a tapered wall thickness variation anomaly that abruptly stops creating a notch-like anomaly. A cross-section is shown in Figure 12. This anomaly could be treated as a metal loss anomaly since one edge is sufficiently abrupt to cause a signal using ultrasonic inspection approaches, but not sharp enough to create a stress concentration sufficient to cause a crack to form and grow. The grain structure shows this anomaly was present when the plate was rolled. The object that

**Figure 11. Image of the ID of a wall thickness variation anomaly.**

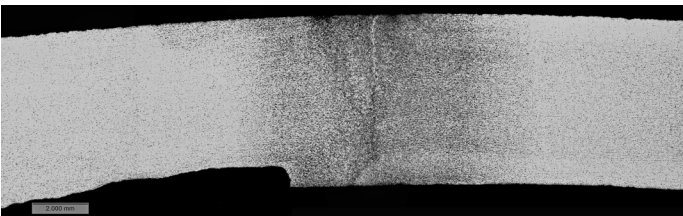
**Figure 12. Cross-section of a wall thickness variation anomaly.**

was rolled in may have fallen out during the pipe forming process since the bondline of the weld seam deviates at the ID. The UT crack ILI tool detected this anomaly with a significant signal from one side, and almost nothing from the other side. Another occurrence of this benign anomaly was found in a different pipe sample. Therefore, since additional anomalies of this benign type could occur in this pipeline, interpretation methods that correlate other ILI data to identify the metal loss component would help avoid unnecessary excavations.
