Wire Rope Electromagnetic Inspection EMAG

Applus+ Velosi use next generation wire rope inspection technology to identify the internal condition of wire ropes. Our equipment can measure loss of metallic cross-sectional area (LMA) caused by external and internal corrosion, wear, broken wires, broken cores and deformations in steel wire ropes.

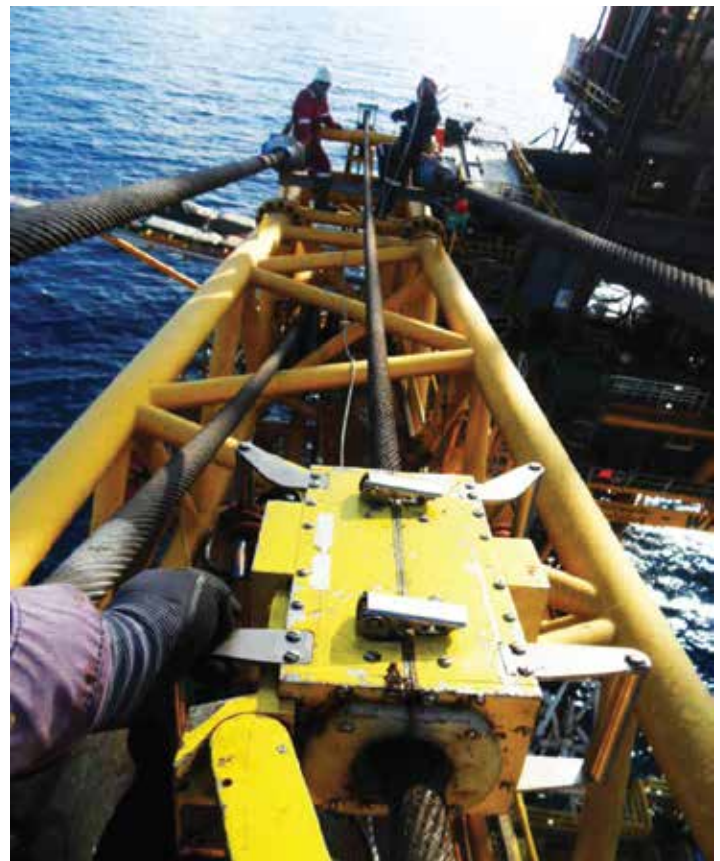
SPECIFICATIONS

Wire Rope Diameters:	Up to 83mm or 3.5"
Flaw Detection:	i) Loss of metallic cross-sectional area (LMA): external and internal broken wires, corrosion, wear, broken cores, various changes of rope structure. ii) Localized flaws (LF): broken wires, corrosion pitting.
Flaw Detectability:	i) Flaw cross section: 0.1% of rope cross-sectional area. ii) Quantitative flaw identification of loss of metallic cross-sectional area for flaws longer than 2" (50 mm), qualitative flaw identification for localized flaws.
Weight:	LMA-300 Sensor Head.....34 kg
Minimum Rope Speed:	0.03 m/ sec
Maximum Rope Speed:	3 m/ sec
Environmental Conditions:	Dust proof, splash proof (oil and water), humidity to 95%
Operating Temperatures:	0°c to 55°c
