Magnetic Flux Leakage (MFL)

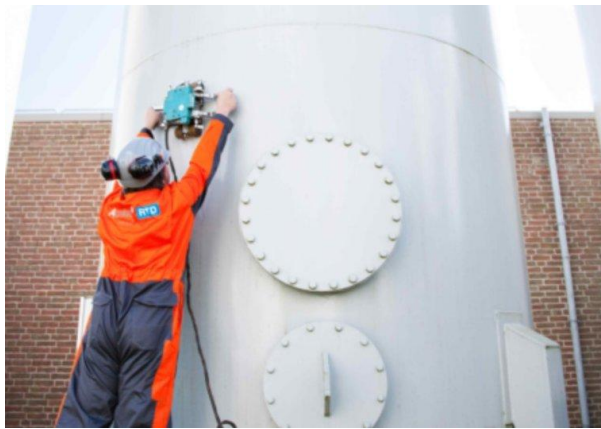
Magnetic flux leakage methods provide asset owners with the information required to assess tank-life suitability. Applus+ employs various scanners to accomplish the integrity assessment, which is generally performed on, yet not limited to, tank floors. Magnetic flux leakage methods work by inducing a strong magnetic field, near saturation, within ferrous materials. When an area affected by corrosion or metallurgical change is traversed by the sensor head, a change in flux density is measured and depicted on a digital computer screen, alerting the operator in real time while also being recorded for post-analysis.
